Flint Public Library

Middleton, Massachusetts

Conditions Assessment

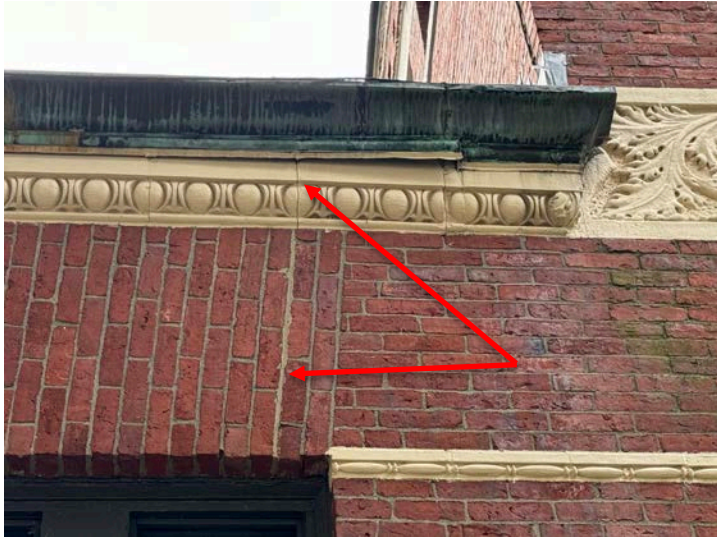
In general, the brick is in very good condition. Some of the mortar used to repoint selective areas is not the best color or texture match to the original mortar, but it all seems to be performing well. There are some step cracks that run through the brick and in some cases the sandstone on the east and north (Fig. 1) elevations. These cracks indicate past or ongoing movement, and they should be monitored to determine if they are still moving. The shifting opened the mortar joints around the step crack, allowing water infiltration at the open joints. Ongoing water infiltration will accelerate the deterioration of the

mortar and surrounding bricks. The movement and step cracks on the east elevation could be related to the excavation for the new addition in 2006.

Fig. 1. Step crack through brick joints and sandstone trim.

- When the building is restored, remove poorly matched mortar and repoint using mortar that matches in color, texture and composition.
- Repoint open joints with mortar matching in color, texture, joint profile and composition.
- If the cracks reappear after repointing, monitor cracks with photographs and measurements biannually. Record the crack width in the summer and the winter due to potential seasonal changes in the joint width due to expansion and contraction of materials. Evaluate the measurements over multiple years to see if the crack is getting progressively larger.
- Inspect the flashing at the southeast chimney to determine if there is any breach in the flashing that is allowing water infiltration. Repair any defects and monitor the attic stairwell during and after rainstorms to determine if the flashing repairs addressed the problem.

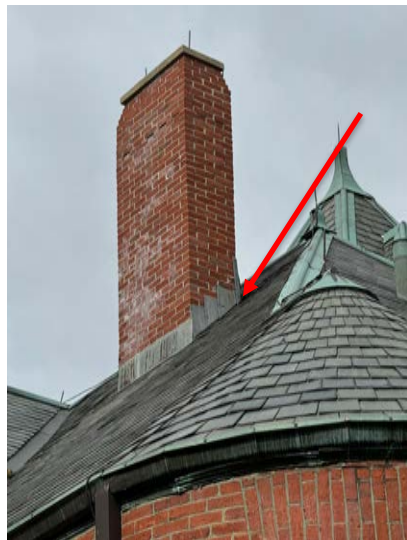
The flashing around the chimney on the southeast roof slope is in poor condition and could be resulting in the leaks observed on the attic stair wall and roof framing. (Fig. 2)

Fig. 2. Flashing around southeast chimney could be causing leaks below.

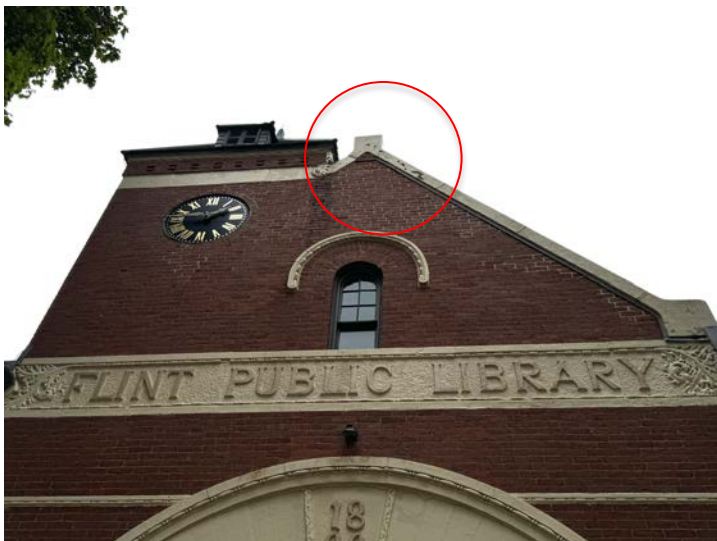
Nova Scotia Sandstone from the Wallace quarries was used for the beltcourses, arch over the main door, cornice, inscription panel and eave. The stone has been coated using a film forming material. It appears to be a non-breathable coating which is leading to it peeling from the stone in sheets. Moisture from the stone tries to evaporate through the exterior surface. When a non-breathable coating is applied, it creates a barrier to the moisture evaporation. The water and moisture build up below the surface of the coating and eventually causes the coating to bubble and peel. It is most evident at the gable stones and the beltcourses. (Figs. 3-4) The peeling will continue as the coating ages. It is not good practice to have a non-breathable coating on stone. It inhibits the natural movement of moisture through the stone and may cause the stone to deteriorate under the coating due to trapped water vapor in the stone pores. The trapped water can freeze in the winter and spall the surface of the stone. The coating is significantly lighter in color than the underlying sandstone, changing the appearance of the building quite dramatically.

Fig. 3. Paint coating peeling from sandstone trim at gable.

- Monitor areas of coating delamination from the sandstone. Remove any bubbled coating that may be trapping water. The areas of delamination will continue to expand and will become increasingly unsightly.
- Plan for the removal of the coating from the sandstone within the next 10 years. The removal of the coating and exposure of the underlying sandstone will reveal a color variation between the existing sandstone and the cast stone used for the addition. BCA recommends accepting this variation and keeping the sandstone uncoated.

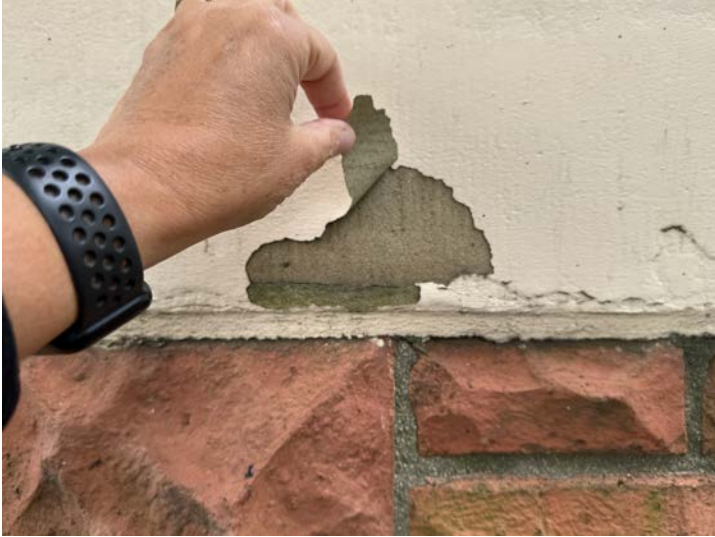
Fig. 4. Paint peeling from sandstone trim at beltcourse.

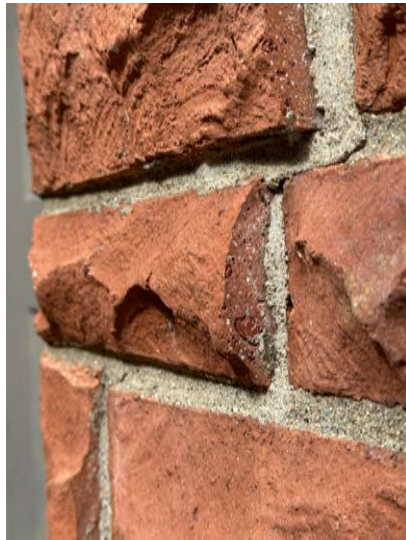
The base of the building, from the ground to the first floor window sill height, is red rusticated block. At a glance, it looks like stone. The National Register nomination form identifies the building base as “rusticated brownstone ashlar”. The material is actually a manufactured product, not natural stone. It could either be fired clay terra cotta or pressed cement blocks. Both products were manufactured during the time period of the building’s construction and would have been a less expensive material than cut stone. The material composition is visible at the basement entry where the blocks were cut around the new basement door opening. Sand and aggregate within a matrix are a clear indication that it is a man-made product. (Fig. 5) There are also duplicate patterns visible when one looks closely. (Fig. 6) The material is in excellent condition and is not experiencing any deterioration, other than some step cracks that are contained within the mortar joints. (Fig. 7) The blocks themselves are not eroding, spalling or deteriorating.

Fig. 5. Cut rusticated base showing clay or cement and aggregate matrix.

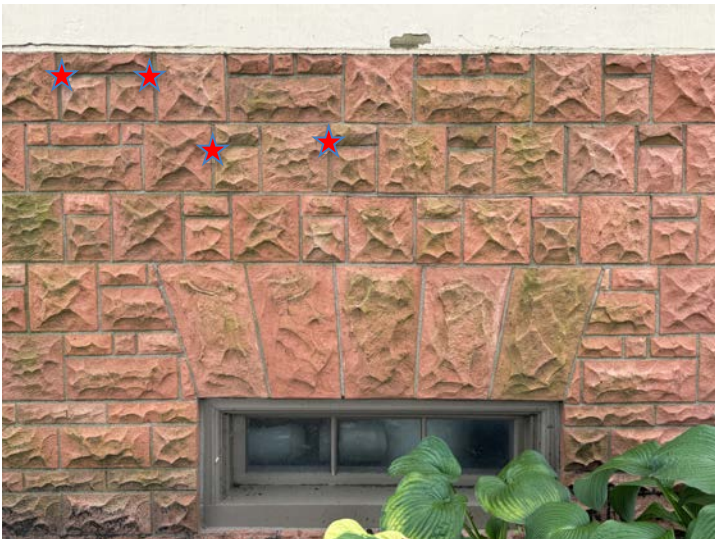
Fig. 6. Rusticated base showing duplicate cast patterns.

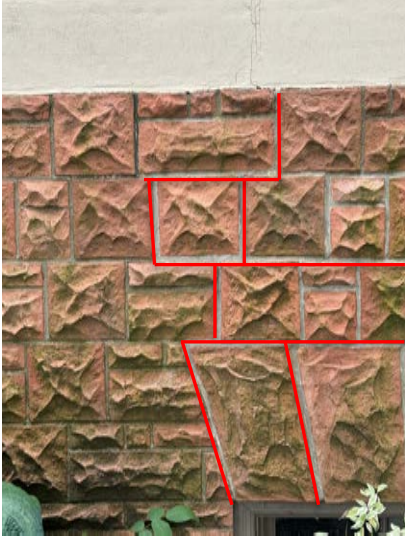
Fig. 7. Step crack through mortar joints. Red lines show locations of open or cracked joints.

- Point open joints at step cracks using mortar to match the existing in color, texture, joint profile and composition.

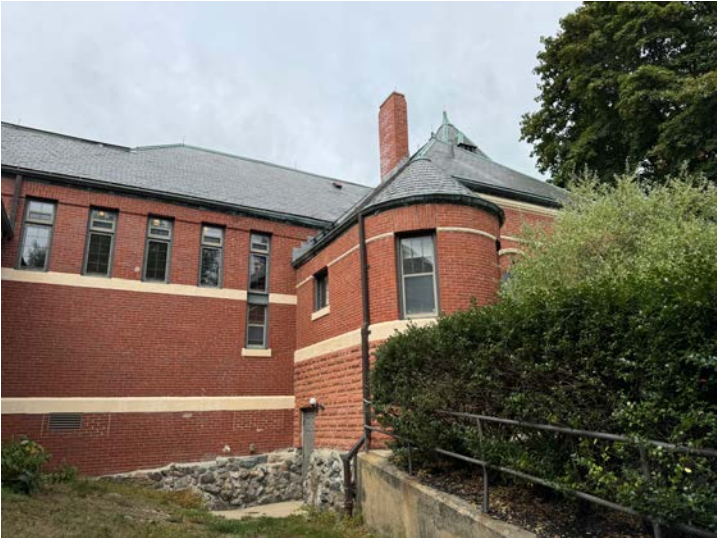
The granite rubble foundation was intended to be below grade and only exposed on the interior basement walls. The rubble foundation is now exposed on the east elevation where the grade was lowered in 2006 to introduce a basement door. The rubble wall was repointed and appears to be in good condition (Fig. 8).

Fig. 8. Exposed granite rubble foundation wall on east elevation.

- No work required at this time. Monitor the condition and include any open joints in future maintenance cycles.

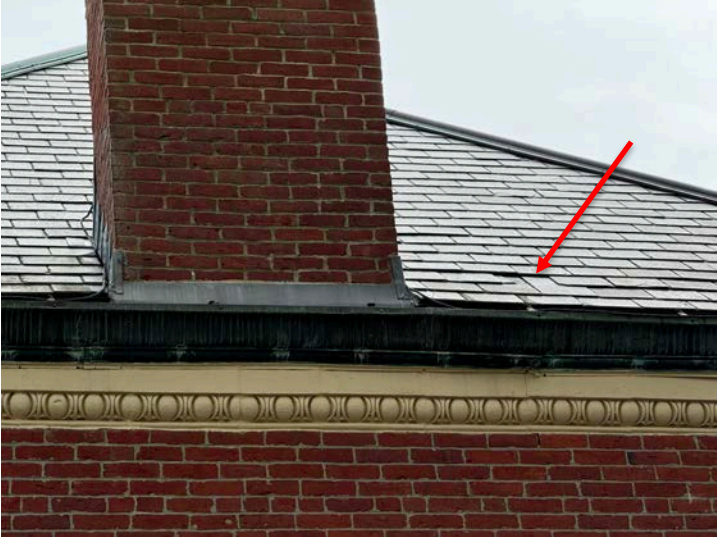
maintained properly it could have another 50 years of useful life. Aside from a few missing, loose and slipped slate, the roof is in good condition. (Fig. 9)

Fig. 9. Slate roof around west chimney showing loose and missing slate.

- Enter into a maintenance contract with a roofing contractor to inspect the roofs and replace all cracked and broken slate each spring and fall to ensure that the roof remains weather tight. The contractor would also point out areas that are beginning to wear and that may be of concern in the coming years.

- Repairs would include replacing loose, missing or cracked slate; patch holes in flashing; reattach lifted or bent flashing, gutters or downspouts; reattached any detached downspouts, etc. With these repairs, the roof could last another 50 years.

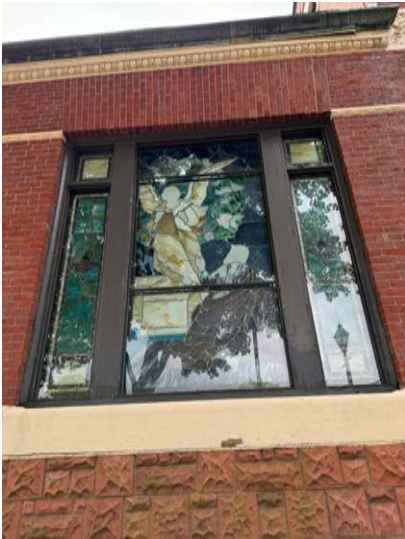
The attic wood window on the north elevation is in poor condition, with significant deterioration of the bottom rail. (Fig. 14) The wood trim around the stained glass window on the north elevation, first floor, is in poor condition with deterioration of the trim around the stained glass. (See Fig. 12)

Fig. 12. Wood window trim is in poor condition, especially at the base of the mullions. Note storm windows on exterior.

- Maintain the operation and repairs to the existing windows.
- Maintain the storm windows to ensure that they continue to protect the wood and stained glass windows.
- Restore the attic windows, including wood consolidation, reglazing and scraping and painting.

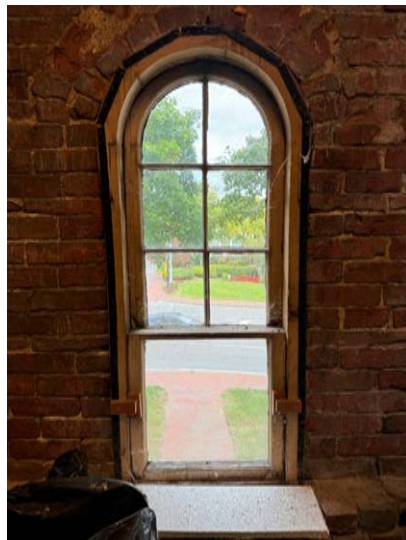
Fig. 14. Double hung wood window in attic in poor condition.

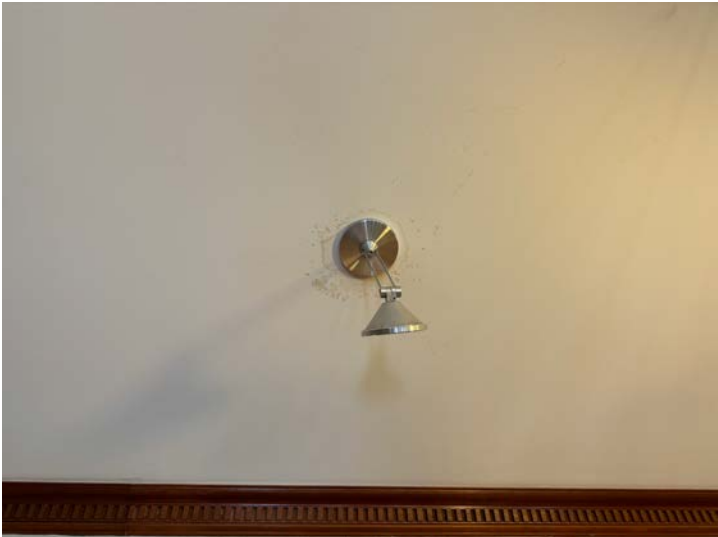
There is evidence of water infiltration around the ceiling lights on the balcony level. (Fig. 17) The ceiling around the fixtures is water stained. It was not possible to view the area above the water stains from the attic due to spray foam insulation and mechanical equipment in the location of the light fixtures. There is no obvious breach in the roof above the light fixtures that would indicate a roof leak. The water or moisture may be related to the mechanical equipment or plumbing lines in the attic.

Fig. 17. Water staining around light fixtures in balcony.

- Continue current approach to maintaining the interior finishes.
- Develop a way to access the attic above the balcony to determine if the water staining around the light fixture is from a breach in the roof or is the result of a water leak or condensation from the mechanical or plumbing system. Once the sources if found, repair the source and repair the plaster finishes around the light fixtures.

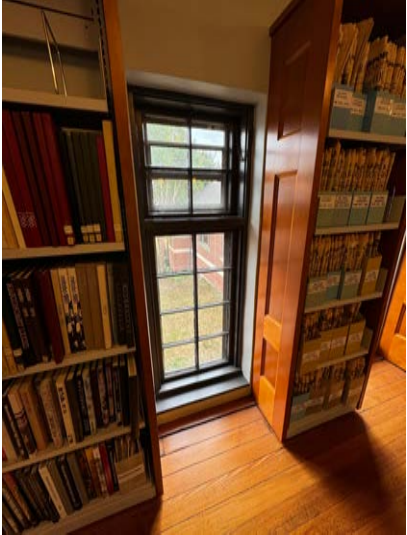
There is a wide gap between the floorboards near the window openings on the north and south walls of the balcony. This gap indicates past or present movement of the wall outward. (Fig. 18)

Fig. 18. Wide gap between floor boards along east and west walls in balcony.

- Monitor the gap between the balcony floor boards to determine if the gap is getting larger, or if it is stable. Document the gap with photographs and measurements biannually. Record the gap width in the summer and the winter due to potential seasonal changes in the gap width due to expansion and contraction of the wood flooring and framing. Evaluate the measurements over multiple years to see if the gap is getting progressively larger. If the gap is progressively expanding, engage a structural engineer well versed in historic buildings to develop a repair for the movement.

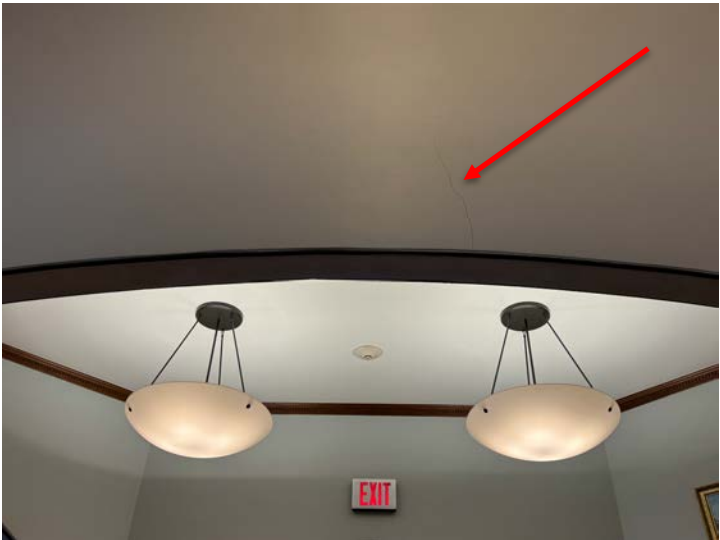
A small crack in the plaster at the central arch over the reading room area was observed. (Fig. 19) This is a large expanse of wall surface. The crack could be caused by seasonal expansion and contraction, or it could be indicative of ongoing structural movement. Due to the small size of the crack, seasonal movement is more likely the cause.

Fig. 19. Small crack in plaster over arch.

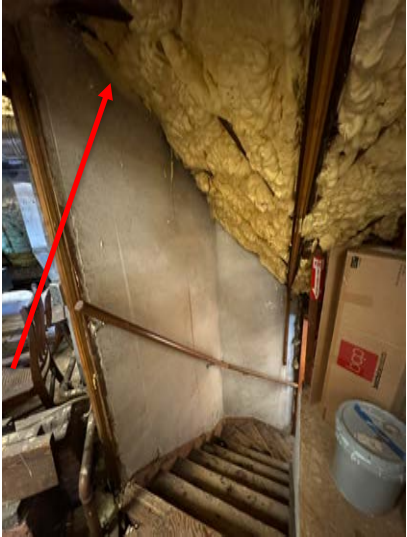
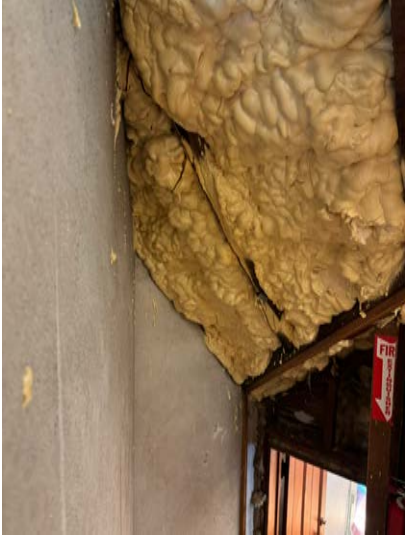
There is a water leak along stair wall to the attic that leaves a small pool of water on the stairs during rainstorms. The leak is located on the wall that abuts the chimney and is most likely related to the chimney flashing. (Figs. 20-21 interior; Fig. 2 exterior)

Fig. 20. Location of water infiltration.

Fig. 21. Location of water infiltration at attic stairs.

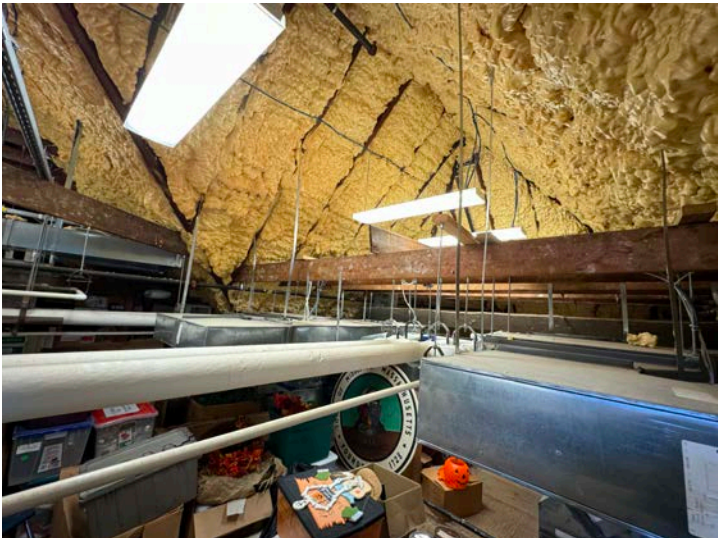
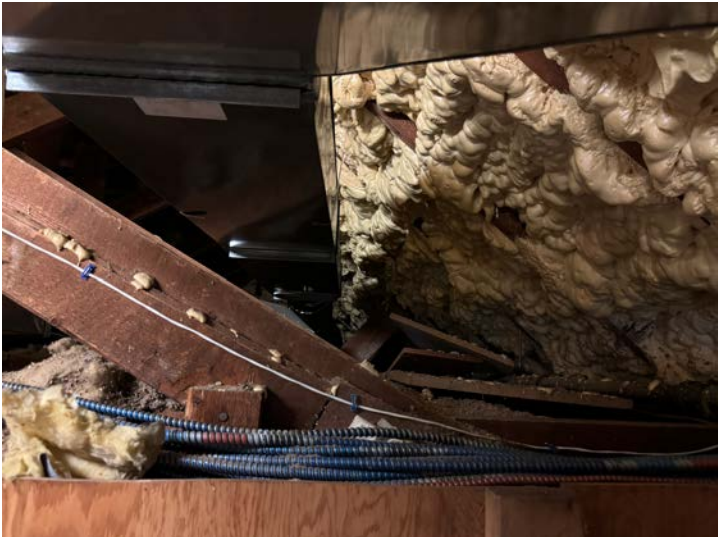
The attic roof and roof framing members were spray foamed, probably as part of the 2006 work. The spray foam makes it difficult to see if or where there is water infiltration. The area of the attic that is over the balcony was not visible, so it is unclear if the water infiltration around the lights is from the roof, or from mechanical or plumbing pipes. (Figs. 22-23)

Fig. 22. Spray foam insulation installed at underside of roof.

Fig. 23. Attic area above balcony light fixtures, inaccessible for leak investigation.

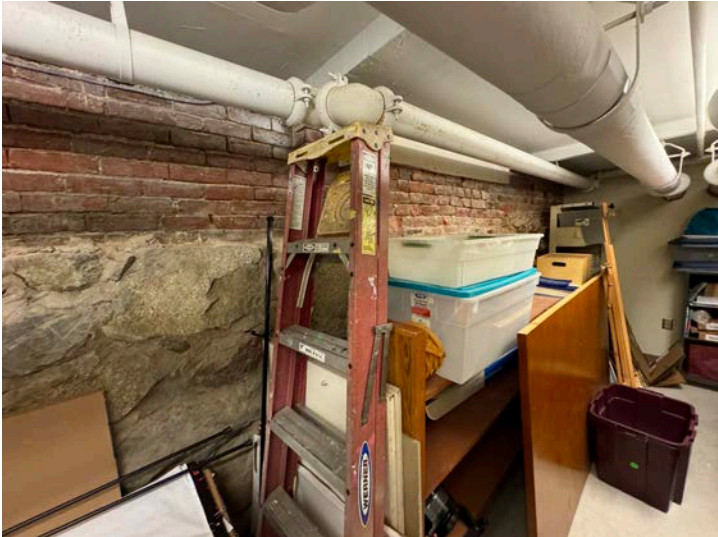
There are exposed brick and rubble stone walls in some areas of the basement. There are small areas of minor mortar deterioration, but the walls are mostly intact and do not require any immediate attention. (Fig. 24)

Fig. 24. Basement walls – brick and rubble stone.

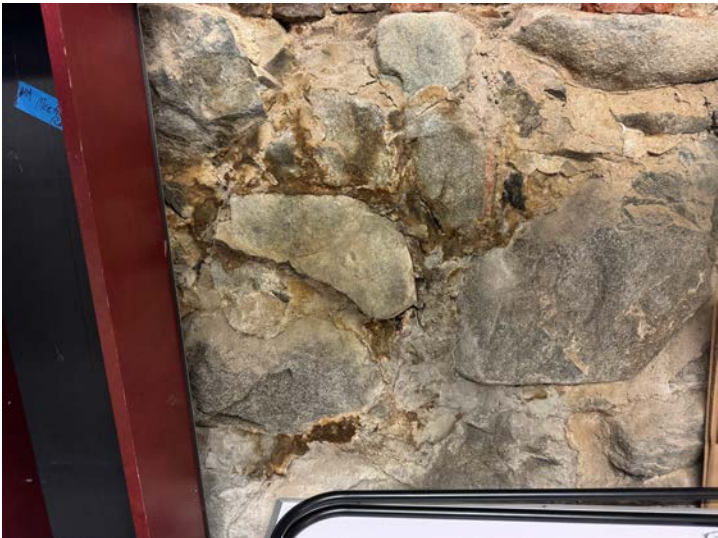
There are some dark mortar stains in the rubble stone walls that are likely caused by minerals leaching from the soil. This is a typical condition in below grade walls and is not a concern, unless increased water infiltration is observed at these locations in the future. (Fig. 25)

Fig. 25. Dark staining at mortar joints, possible mineral leaching from soil.

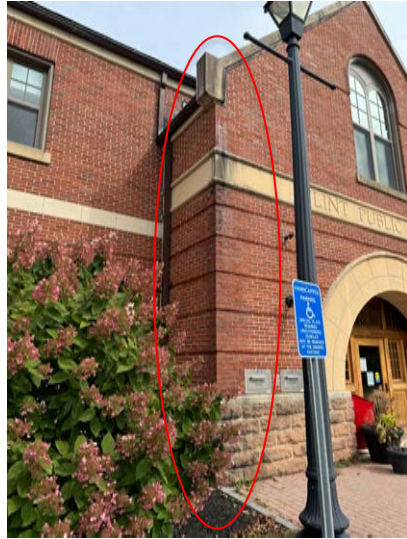
There is some dark soiling to the left and right of the south entrance. Water runoff from the gable capstones is depositing atmospheric soiling on the corners of the entrance. This is unsightly and is causing deterioration of the mortar joints due to ongoing saturation of the brick. (Fig. 26)

Fig. 26. Dark soiling from gable runoff.

- Repoint all open joints using mortar to match the surrounding in color, texture, joint profile and composition.
- Clean the dark soiling from the brick and cast stone on either side of the south entrance after water diversion at the gable is installed. Repoint any deteriorated joints at this location.

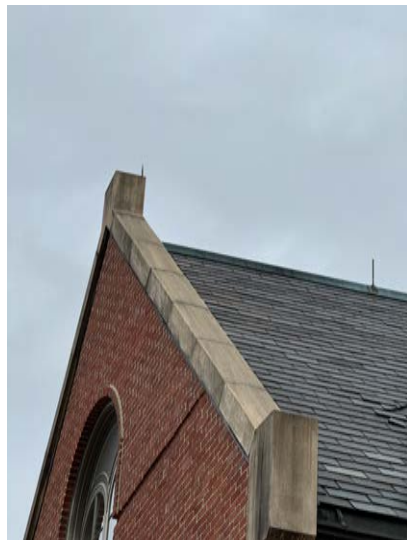
Cast stone was used for the rusticated base, beltcourses and gable stones. A large arch with an inscription panel above creates the south entrance. This entrance is accessible and off of the parking lot. The color of the cast stone is more yellow than the sandstone on the original building. Either the cast stone was colored to replicate the coated sandstone, or the sandstone was coated to match the cast stone on the addition. Through wall flashing was installed under the gable stones to provide an additional layer of protection to the underlying brick walls. (Fig. 27) While the installation of through wall flashing protects the brick wall from water saturation through the cap, the gable cap stones are flat on the top. In heavy rains, water runs down the gable slope and down the face of the brick surrounding the entrance.

Fig. 27. Cast stone gable with through wall flashing between cast stone and brick.

- Install a water diverter on the top of the gable stones to keep the water from running down the gable stones and onto the face of the brick at the entrance. The roofing maintenance contractor can construct a diverter for this location.

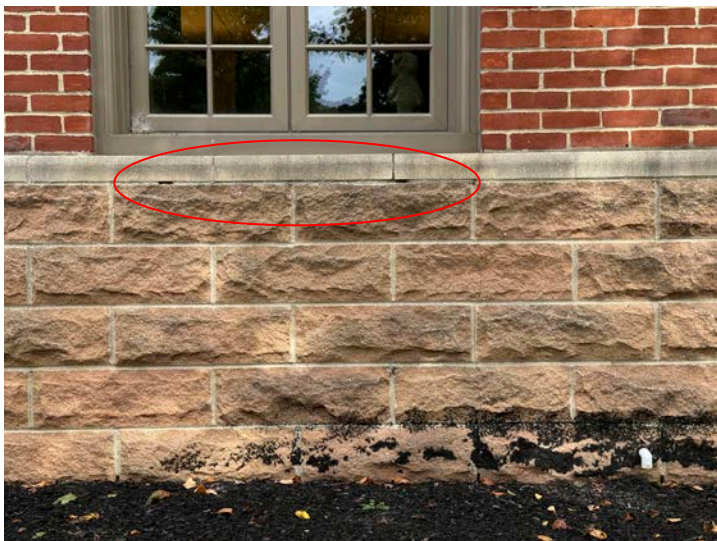
There are some open or missing mortar joints, especially at the projecting belt course (Fig. 28), in the rusticated base, and at the large entrance arch (Fig. 29). There are isolated cracks through cast stone units. (Fig. 30) This tends to occur on long walls and is most likely due to expansion and contraction of the materials over time, and not indicative of ongoing settlement or movement of the walls.

Fig. 28. Open mortar joints at the belt course and base.

- Repoint all open mortar joints at the belt course projection and at step cracks in the rusticated base and cornice. Use mortar that matches the surrounding in color, texture, joint profile and composition.

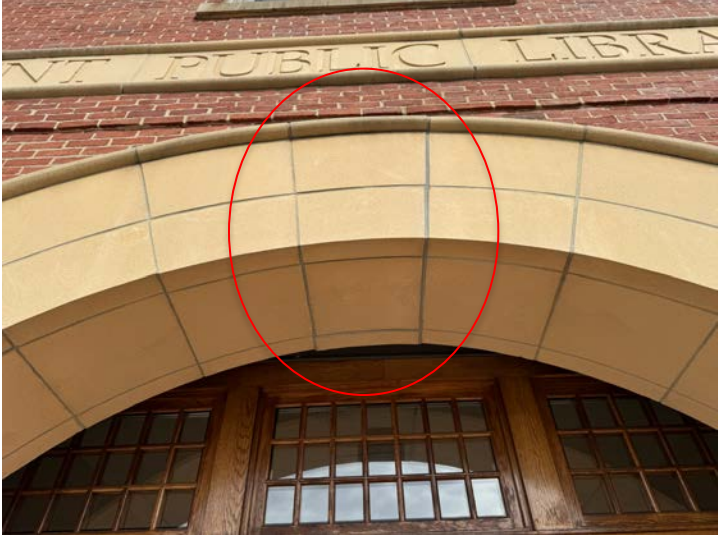
Fig. 29. Open mortar joints in arch.

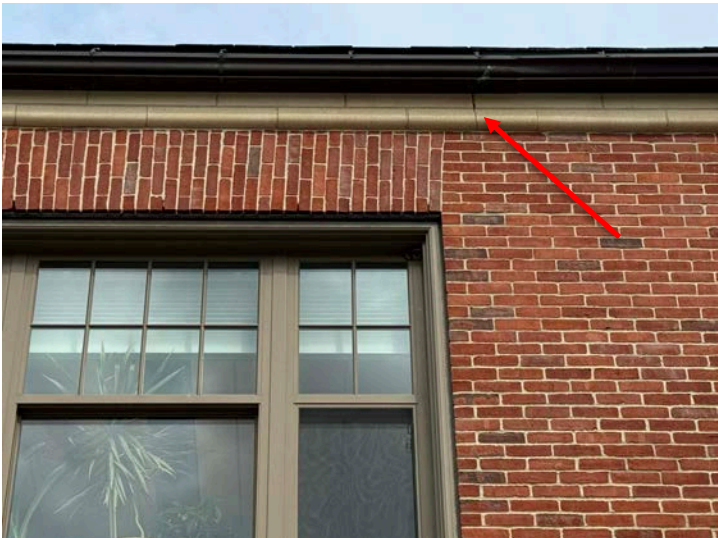
Fig. 30. Isolated cracks in cast stone.

- Patch cracks in cast stone using a cementitious patching material that matches the color and texture of the cast stone.
- If repaired cast stone cracks or open mortar joints reappear after repointing, monitor cracks with photographs and measurements biannually. Record the crack width in the summer and the winter due to potential seasonal changes in the joint width due to expansion and contraction of materials. Evaluate the measurements over multiple years to see if the crack is getting progressively larger. If the cracks are getting progressively wider over time, engage a structural engineer well versed in historic buildings to evaluate the source of the movement.

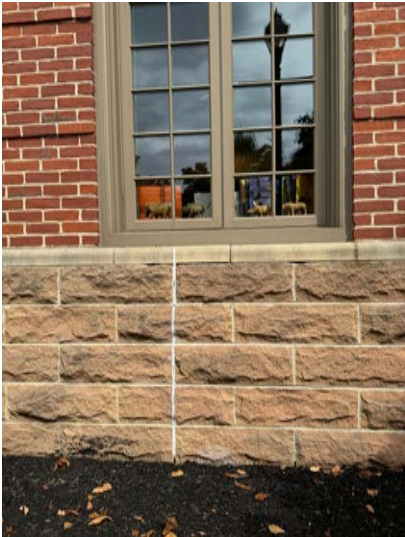
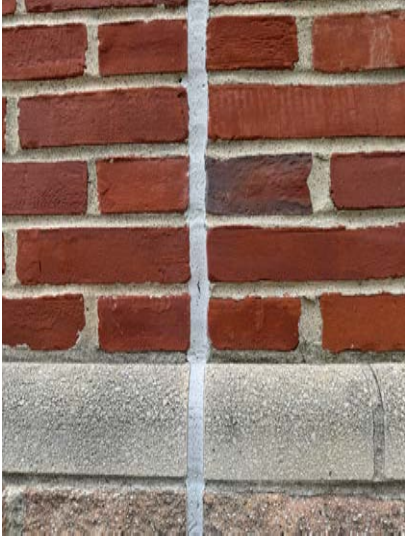
Sealant was used at the control joints in the base. The sealant is starting to dry up, shrink and pull away from the cast stone. (Figs. 31-32) Sealant typically requires removal and reinstallation every 20-25 years. The sealant installed in 2006 is nearing the end of its lifespan.

Fig. 31. Sealant material at expansion joints dried and shrinking.

Fig. 32. Sealant material at expansion joints dried and shrinking.

- Remove the sealant at the control joints and reinstall. Choose a color that matches the surrounding brick or cast stone.
- Remove and reset the east stairwell capstones. Install stainless steel pins in the brick wall below to hold the capstones from moving. Properly flash the pins to ensure there is no water infiltration around the pins, into the wall below.

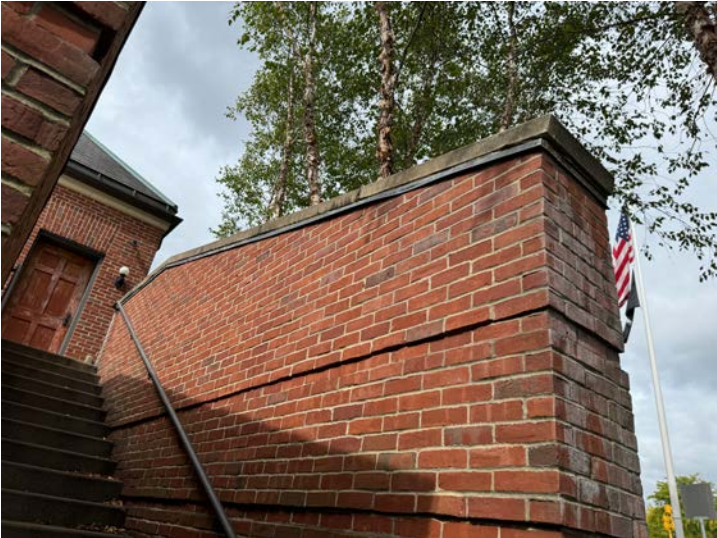
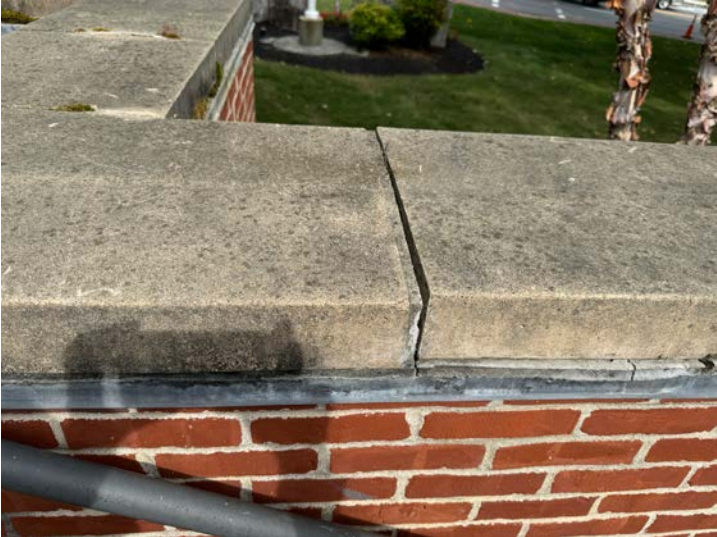
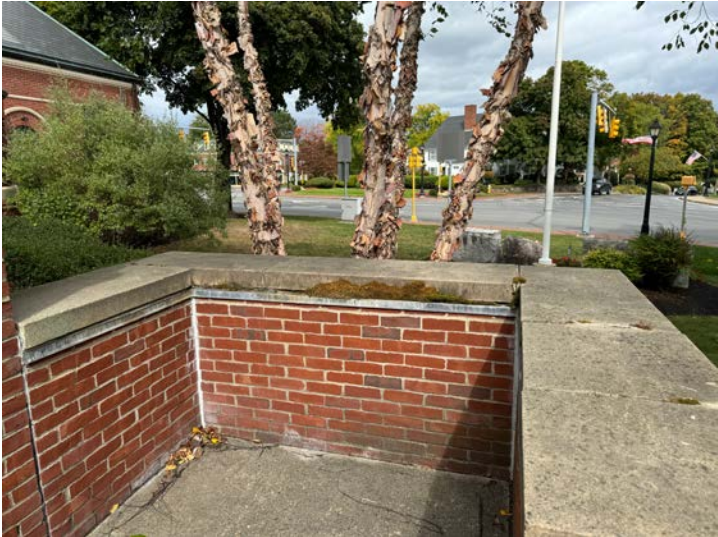
The capstones on the stairwell walls that lead up to the flat roof on the east end of the addition are shifting. The capstones do not appear to be pinned in place and are shifting out of plane due to water infiltration and lifting due to freeze/thaw action on the saturated bed mortar joints. Fortunately, through wall flashing was installed between the brick wall and the capstones so that the brick wall is protected. The mortar joints between the capstones are failing and the bed joints are getting saturated and failing, leading to the shifting of the capstones out of plane with the wall and biological growth in the mortar joints. (Figs. 33-35)

Fig. 33. Capstones at east stairs are shifting.

Fig. 34. Gaps at joints between shifting capstones.

Fig. 35. Biological growth at stair capstone joints.

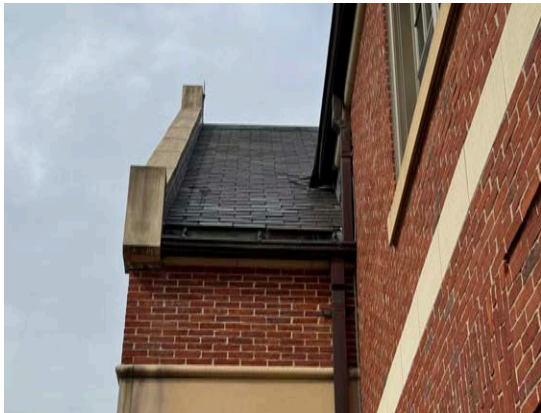
The roof is non fading black slate with copper hips, valleys, gutters and downspouts. The slate and associated flashings are in good condition. Although documentation could not be found, the slate appears to be North Country Unfading Black from a quarry in Quebec, Canada. If that is the case, it has a life expectancy of at least 150 years. There are some missing and loose slate that require repairs. (Fig. 36)

Fig. 36. Missing and loose slate.

- Hire a slate roofing company to do annual inspections and minor repairs. They would come in once or twice a year to inspect the roof and perform minor repairs to the slate and flashing. Repairs would include replacing loose, missing, or cracked slate; patch holes in flashing; reattach lifted or bent flashing, gutters or downspouts; reattached any detached downspouts, etc. With these repairs, the slate could last another 150 years and the flashings could last another 25 years.

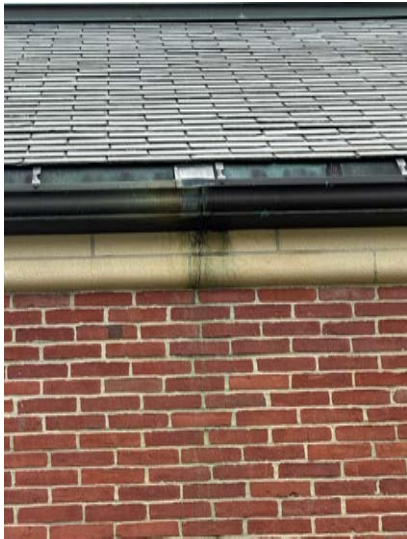
The gutters and downspouts are in good condition, with one exception. There appears to be a broken solder seam at a gutter on the west elevation. The open gutter seam is causing water to run down the face of the masonry, saturating it and leaving copper stains. (Fig. 37) Copper elements have a life span of 30-40 years for valleys, gutters and downspouts (they experience more wear from running water), and 50-75 years for hip flashings.

Fig. 37. Open seam on copper gutter causing copper staining below.

- Make sure that slate used for repairs and replacement of individual shingles matches the color, texture, thickness, sheen, and quality of the original.
- Repair the solder seam at the west elevation gutter. Inspect and clean out all gutters and downspouts as part of the annual roof maintenance.

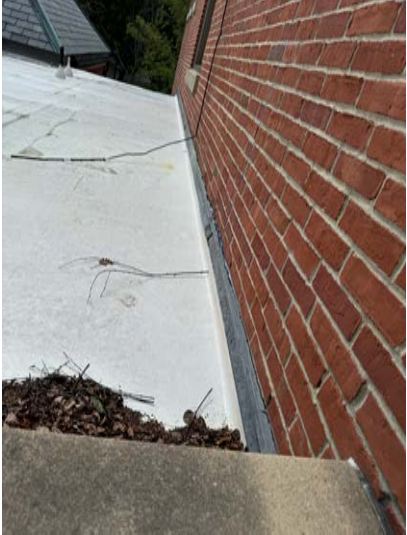
The membrane roof over the eastern end of the children's library appears to be in good condition. If it is the roof that was installed in 2006, it likely has another 15 years of life remaining before it needs to be replaced. There have been ongoing issues with the counterflashing from the roof to the brick wall. This is the location of the water staining on the drop ceiling tiles below. (Fig. 38)

Fig. 38. Defective flashing above water leaks in Children's Library ceiling tile.

- Monitor the condition of the membrane roof over the eastern and western ends of the building. The roofs will need to be replaced in 10-15 years.
- Replace the counterflashing at where the eastern flat roof meets the brick wall. Make sure that the flashing is properly installed to rectify the ongoing leak to the children's library below.

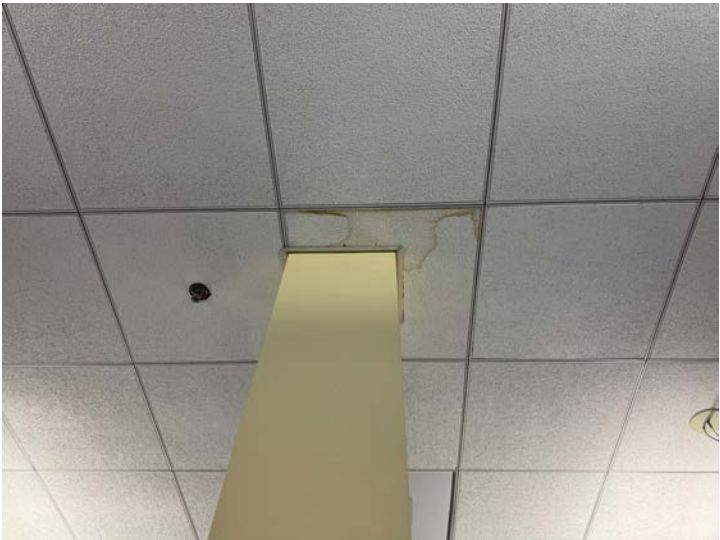
Water leaks have stained the drop ceiling in the children's library, directly below the exterior wall and flat roof flashing above. (Fig. 39)

Fig. 39. Water leaks below defective flashing at flat roof above.
