Flint Public Library

Middleton, Massachusetts

Conditions Assessment

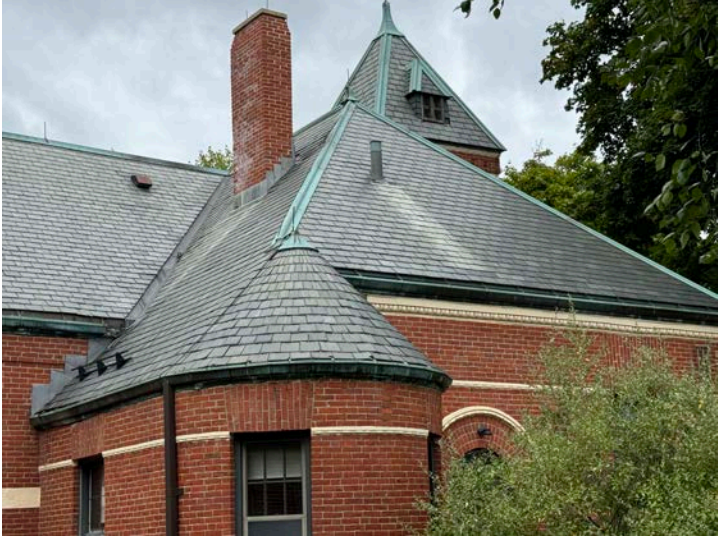
The copper flashings and gutters have a 30-50 year life span and typically require replacement before the slate roofing materials. Water runoff wears holes in the gutters and the flashing, which often directs water to the interior of the masonry walls or wood trim. These elements are in varying conditions around the building, from good to poor. Some have been replaced as they have worn out, others are nearing the end of their lifespan and require replacement in the near future. The copper hip flashing was called for replacement in 2006 documents, but it looks like it was not replaced. The step flashing around the north gable, tower and chimneys appears to be in very good condition, indicating that it may have been replaced in 2006. (Fig. 10) It is unclear what the age of the gutters and downspouts are, but they appear to be functioning properly and not exhibiting signs of wear.

Fig. 10. Copper gutters, downspouts, valleys and hips.

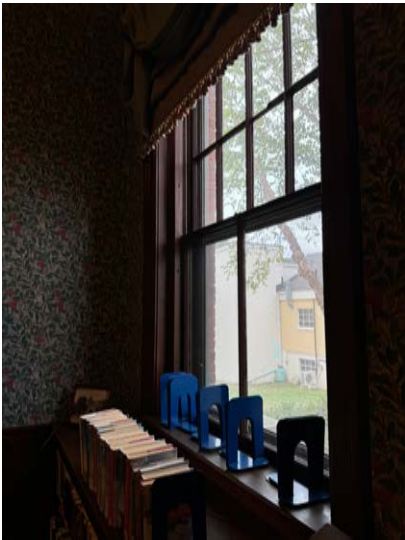
The original wood windows are intact and appear to be in good condition. (Fig. 11) There are stained glass windows in the two north openings. Aluminum storm windows were installed over the wood windows and the stained glass windows, possibly as part of the 2006 work. They help to protect the original wood and stained glass windows and appear to be functioning properly. The presence of the storm windows made review of the wood trim and exterior surface of the windows difficult. (Fig. 12) The wood windows appear to be in good condition, except as noted below. There was no obvious bowing or sagging of the lead observed at the stained glass windows. (Fig. 13)

Fig. 11. Original double hung wood window.

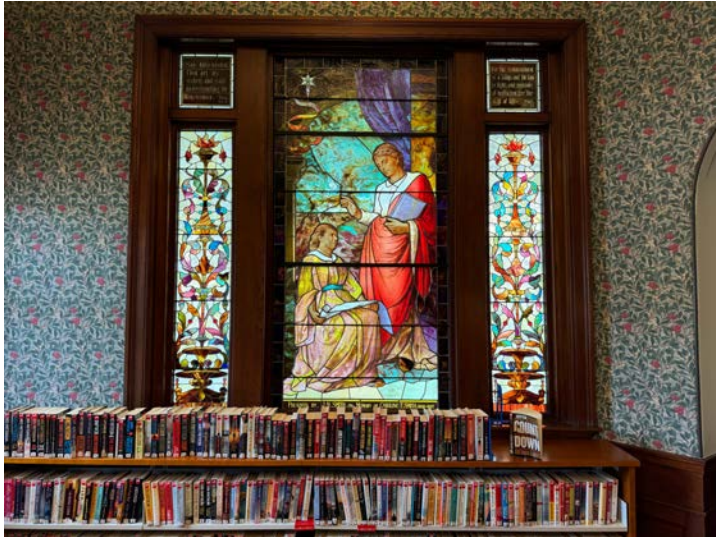
Fig. 13. Stained glass window in parlor.
